Urban Stream Restoration Protects Access Road

The City of Atlanta's SWAT team has a single two-lane road as the only access point to their main training center. Located south of Atlanta this access road is situated on a narrow tract of land between an in-remediation landfill (closed to dumping) and Intrenchment Creek. Across Intrenchment Creek is a City of Atlanta sewer treatment plant. Due to severe bank erosion along the creek, the access road had been reduced to a single lane. The

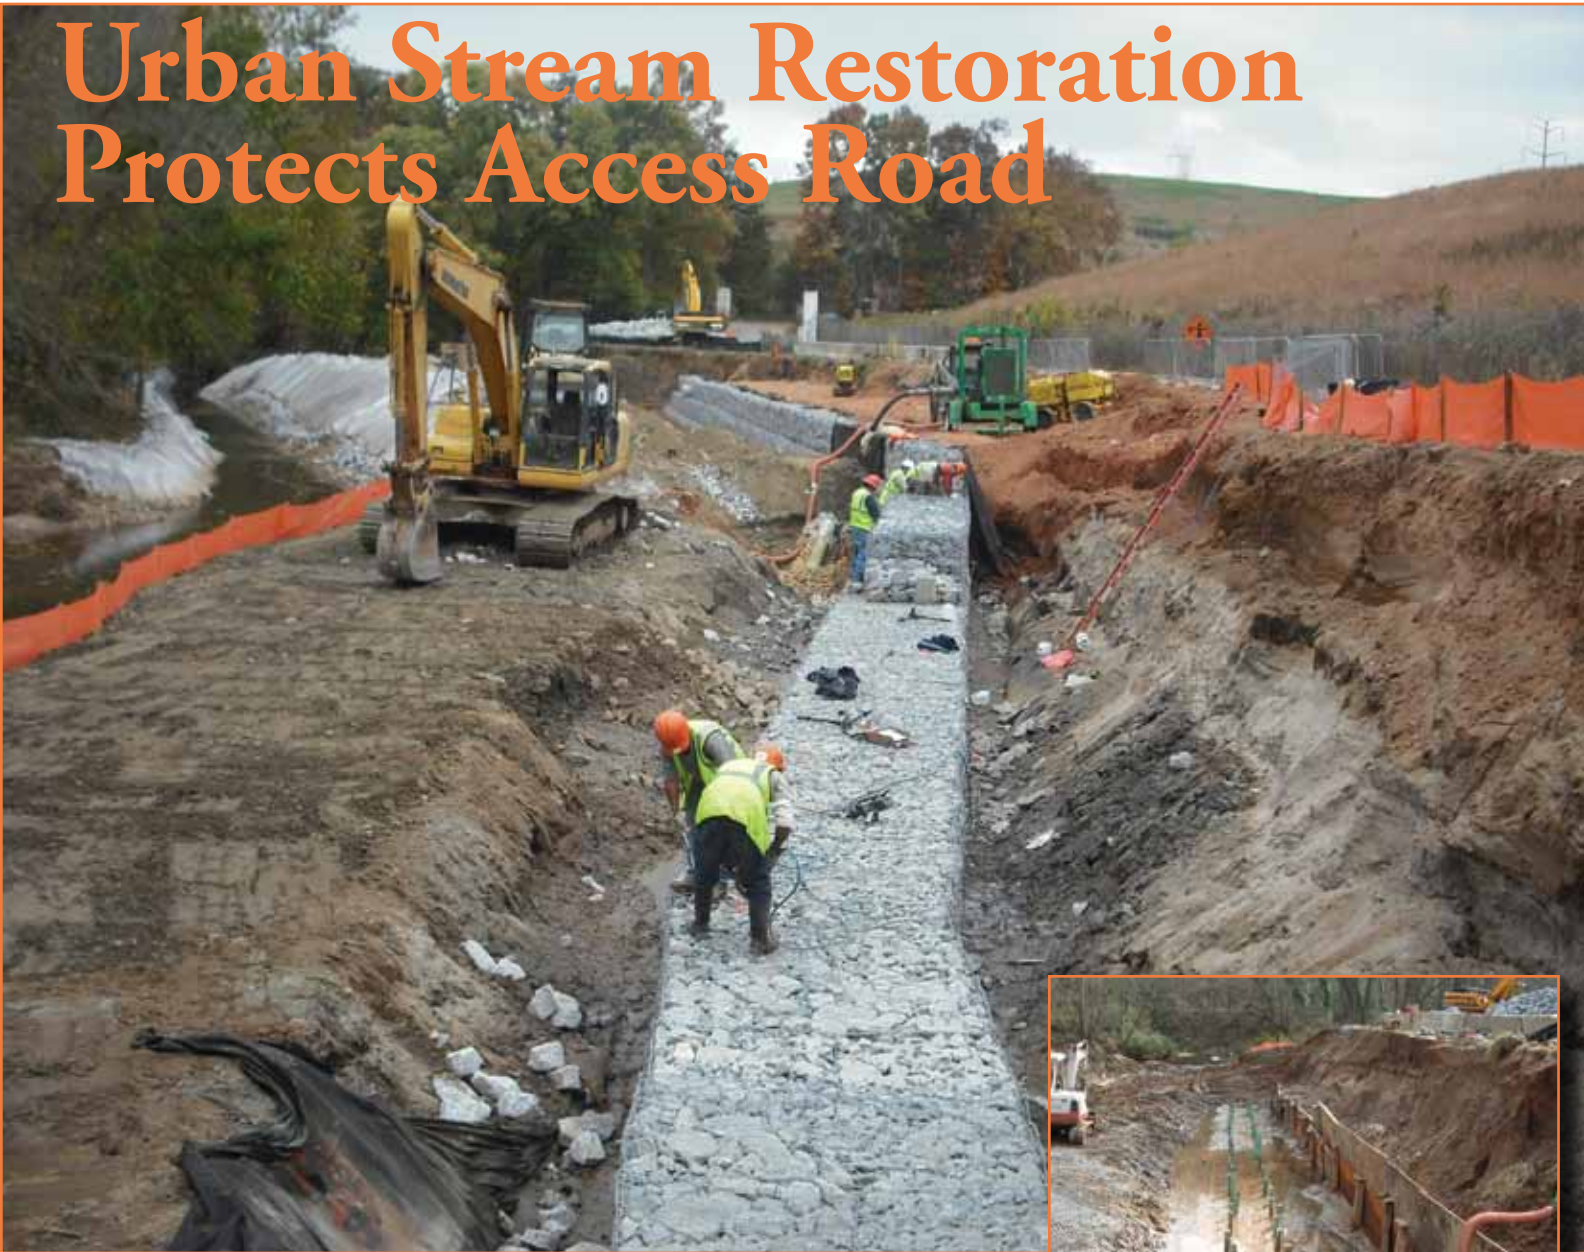
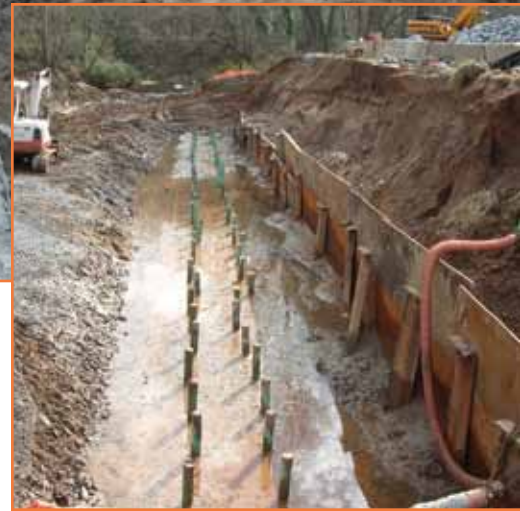
Workers install gabion baskets (above). Concrete foundation poured and ready for gabion basket installation (inset).

Once stream flow had been transferred to the temporary by-pass channel, construction on the main Maccaferri gabion wall began. The design plans had called for rebar to be drilled and grouted into the bedrock below the gabion wall. Upon excavation no bedrock was found up to 10 feet below the existing stream bottom. The soils report, which showed bedrock 1 to 2 feet under the stream, had been incorrect or misinterpreted with the design work. To ensure the stability of the gabion wall without a connection to bedrock, the design firm CH2M Hill reworked the requirements and requested a concrete footing with a solid interface to the gabion wall. Eventually an 18-inch concrete footing was poured below the

lowest gabion and steel reinforced bollards were extended to coincide with the middle of each 6x3x3 gabion basket. It was critical to construct the gabion wall as quickly as possible to secure the roadway. Intrenchment Creek epitomizes urban stream flow where rapid flow increases occur following any substantial storm events. The typical flow along Intrenchment Creek is around 7 CFS and at the work site this equated to a water depth of around 1 - 2 feet. During one severe storm event over 2 inches of rain fell across Atlanta in a few hours and the worksite water levels rose to over 10 feet in about that same amount of time. It was difficult at first to anticipate the amount of power and erosion that these flows are capable of when looking at the stream during normal flow conditions.

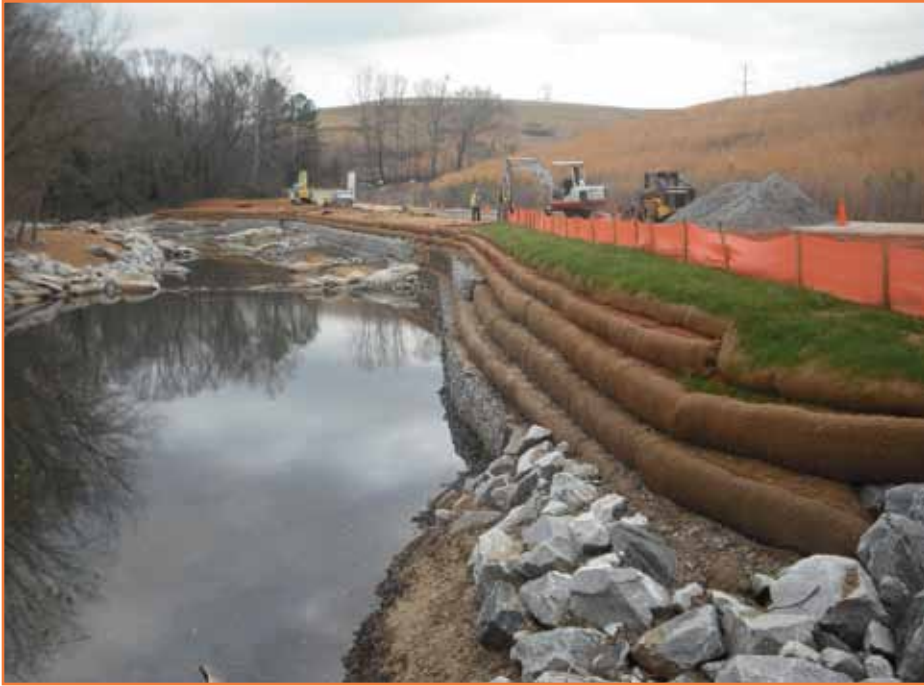
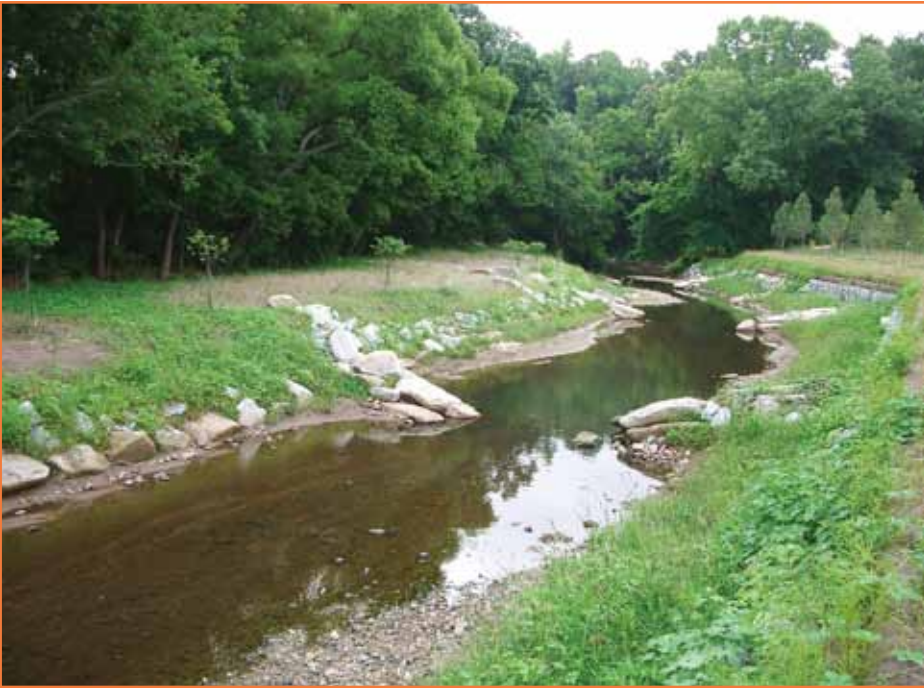
Crews complete final restoration before landscaping (above). Two months after completion the stream has begun to stabilize (below).

After the hardscape features had been completed, landscaping began. Seeding was done after final grading and installation of Rolanka BioD-Mat 70 blanket to support growth and development of vegetation. Eight hundred live stakes were planted and all disturbed areas were seeded with a native grass seed mix prepared by Mellow Marsh Farms. Finally, native trees and bushes completed a very park like feel to the area with the accent of water tumbling over the cross vane structures. The project was completed the end of May 2009 at a final cost of \$815,000. The access road leading to the SWAT training facility was restored to it's fully functioning two-lanes due to the 35 feet gained from the streambank stabilization project.

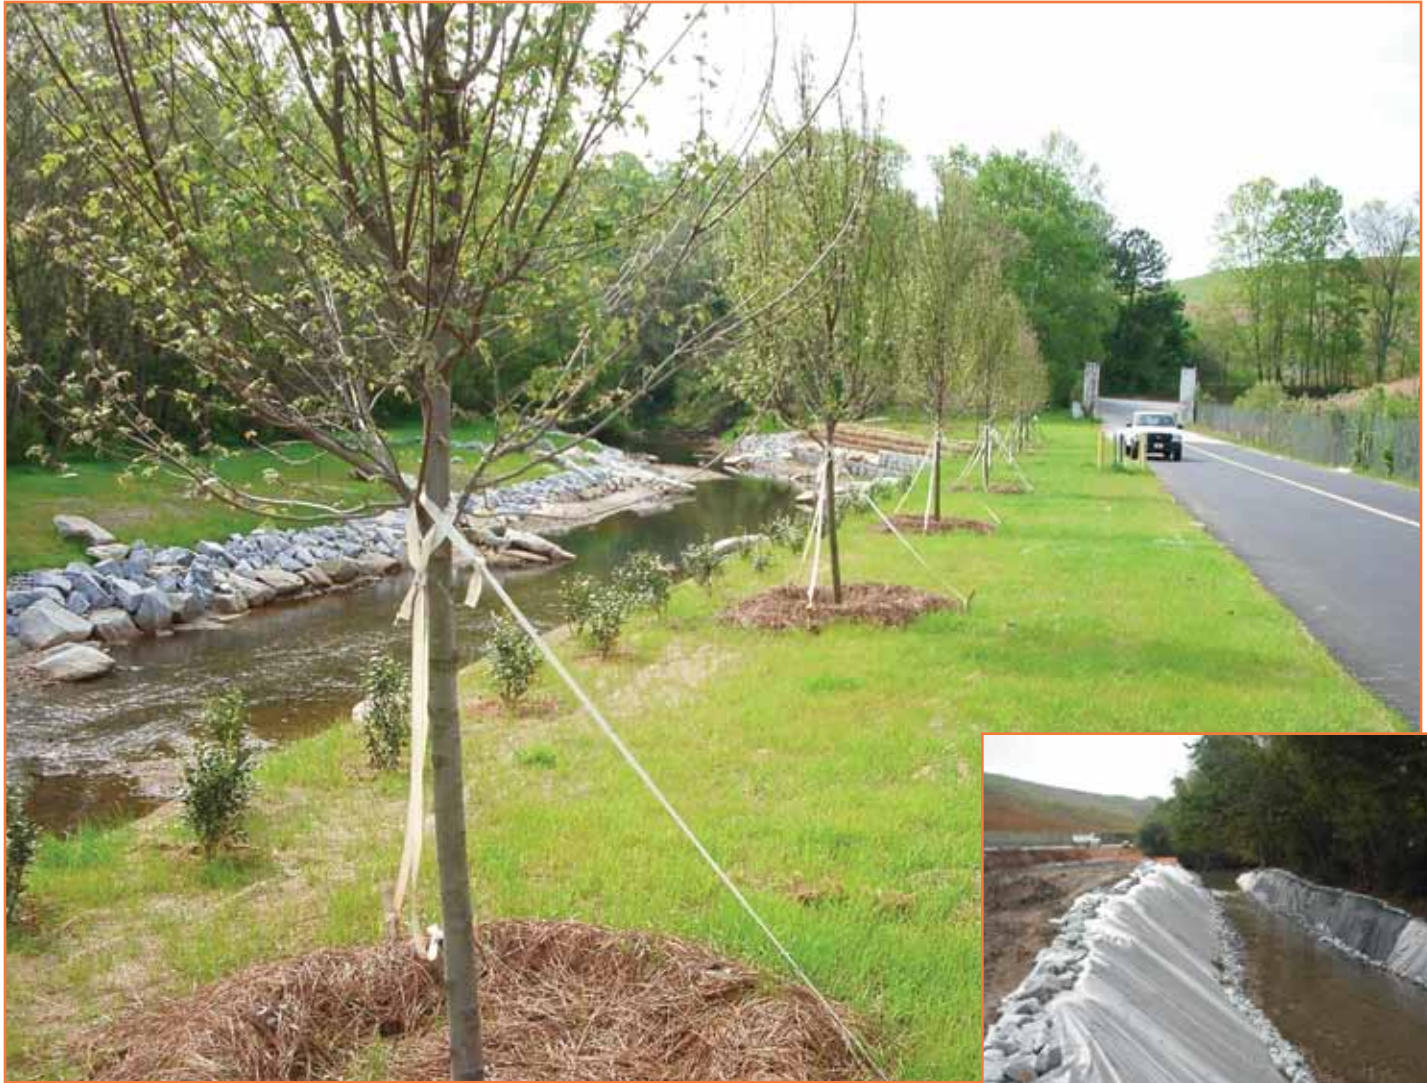
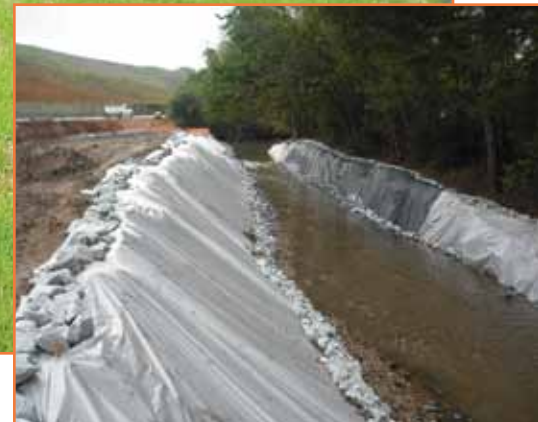
View looking upstream to downstream of completed project (above). Temporary by-pass channel (inset).

construction in early August 2008. The first step of construction was a temporary by-pass channel for Intrenchment Creek. Working downstream to upstream, an 800 ft long bypass channel was excavated by removing 3000 cubic yards of dirt. Before flow was transferred into the temporary by-pass channel, the newly excavated area was lined with a 6 mil plastic liner. However, after about two weeks of usage, it was obvious the thin plastic liner wasn't able to withstand rain events and was already tearing. Portions of the stream flow were threatening to undermine the liner entirely. The decision was made to switch to 180EX, a non-woven geotextile fabric from Thrace-LINQ, Inc., manufactured from polypropylene staple fiber. The geotextile was installed during a low-flow event one 10 foot section at a time. The non-woven fabric would prove durable

enough to last until flow was transferred back to the main channel five months later.
